**DORIS - Ground Deformations Risk Scenarios:
an Advanced Assessment Service**

**WP5 – Assessment maps delivery and design of
risk scenarios**

DELIVERABLE No. 5.6

Damage assessment maps (1:5.000)

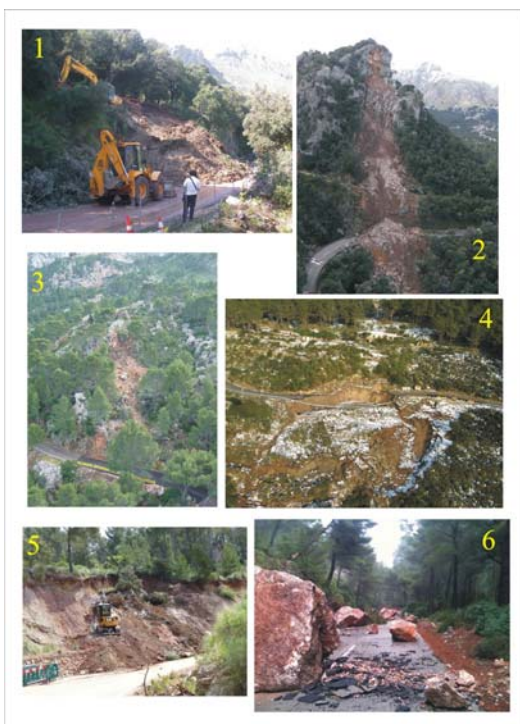
Figure 1 Photographs of the most important movements affecting the Ma-10 road. 1) Sa Calobra (3/12/2008), 2) Gorg Blau (31/12/2008), 3) Estellencs (15/01/2010), 4) Estellencs (8/03/2010), 5) Banyalbufar (09/05/2010) and 6) Pilar (12/10/2010).

The Ma-10 road, located on the northern face of the mountain range, has heavy traffic estimated at 7,200 vehicles per day on average, and constitutes the main road of this region. During 2008-2010 18 mass movements affected this road (Fig1). Rockfalls have been the most hazardous, being noted the Gorg Blau rockfall on 31st December 2008 (Fig1-2) and Estellencs landslide on 8th March 2010 (Fig1-4), which blocked the Ma-10 road for three and a half months, cutting off the access to several locations and villages.

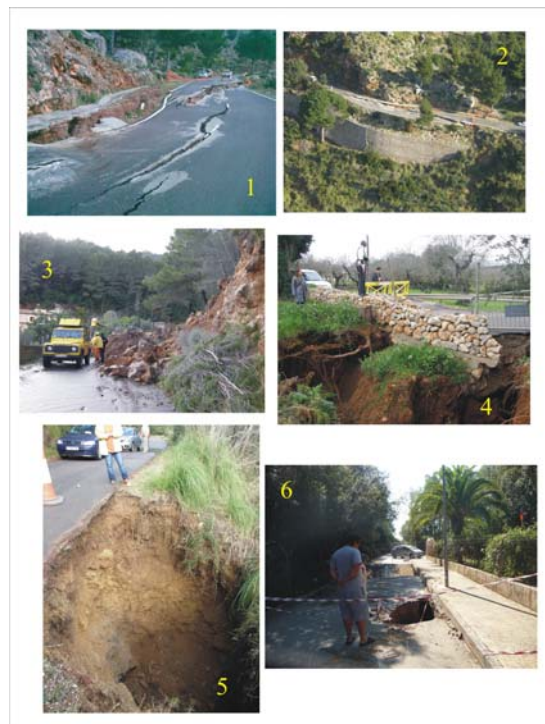
Figure 2 Photographs of secondary roads on the range affected by landslides and karstic collapses (sinkholes). 1 and 2) Cala Tuent landslide (15/12/2008), 3) Es Verger landslide (15/12/2008), 4) Búger sinkhole (Jan 2010), 5) Es Verger sinkhole (15/12/2008) and 6) Crestatx sinkhole (3/5/2010).

Secondary roads through the range have also been affected by landslides, especially by karstic collapses. In Majorca, the predominance of a carbonated rocky substrate, mainly limestone and dolomite from the Lower Jurassic, determines the occurrence of common processes in karstic areas, like sinkholes and shallow subsidence depressions. During the past two years, pre-existing holes have increased considerably. This is mainly due to the increase of the recharge prompted by the intense and continuous rainfall on the island. This additional recharge has not only led to an elevation in the piezometric level of the aquifers, but also (1) a rise in the load due to soil saturation, (2) a loss in internal resistance of the surface materials, (3) the increase in the dissolution processes which affect the rocky substrate, (4) the migration towards the surface of the cavities and cracks formed in the rock (Hyatt & Jacobs, 1996, Benito et al., 1995). The results are some karstic collapses with a clear visualization on roads.

Fig. 2 (4,5,6) shows some karstic collapses affecting the road network as well as the Cala Tuent landslide (fig 2-1,2) which blocked the road and cut off the tourist resort of Cala Tuent for a couple of months.

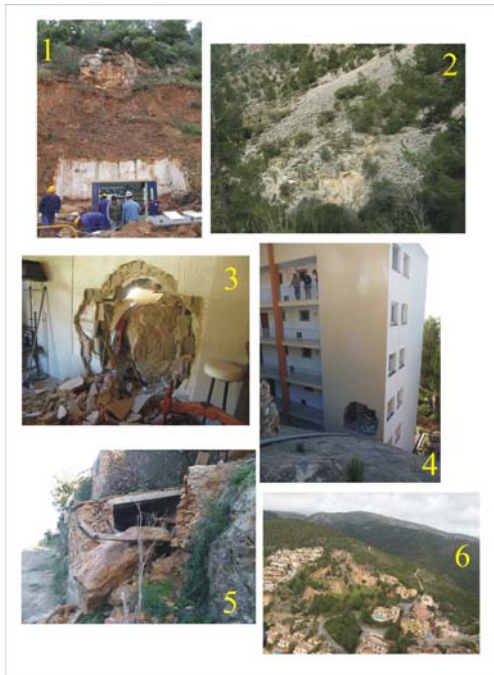
Figure 3 Damage caused to buildings, dwellings and others by rockfalls and landslides during 2008-2010 in several places on the range. 1) Deià power station (29/10/2008), 2) Biniaraix (6/01/2009), 3) Puigpunyent (14/09/2009), 4) Siesta (8/01/2009), 5) Son Albertí (Jan 2010) and 6) Costa d'en Blanes (Jan 2010).

Rockfalls and landslides during 2008-2010 have also caused serious damage to buildings, holiday houses, dwellings and a power station in several places through the range. The area of Costa d'en Blanes, in the southern sector of the Tramuntana Range, should be noted, where 17 holiday houses haven been evacuated due to the impending

risk of a large rockfall. This urban area was built in the 90`s surrounding a former gypsum quarry (Fig. 3-6). The geology determines the movement. Highly karstified carbonatic rocks (limestone) outcrop on the surface with a thickness of up to 10 m. At the base of the quarry, and below the limestone, we can see the marls which gypsum which were exploited during the mining activity. Large blocks of limestone are sliding over the soft materials, and large cracks have recently appeared at the top of the quarry, affecting some of the houses. Small rockfalls have also affected houses (Fig. 3-2,3,5) and apartment blocks (Fig. 3-4) causing a great alarm in the population. Fortunately, there were no deaths. Damages to barns and a power station (Fig. 3- 1) have also been registered.
